# Cornet Creek Drainage Maintenance and Flood Mitigation Study, Colorado

**MEI**<sup>™</sup>  
**Mussetter Engineering, Inc.**  
1730 S. College Avenue, Suite 100  
Fort Collins, Colorado 80525  
MEI Project 07-14

**March 11, 2008**

# **CORNET CREEK DRAINAGE MAINTENANCE AND FLOOD MITIGATION STUDY EXECUTIVE SUMMARY**

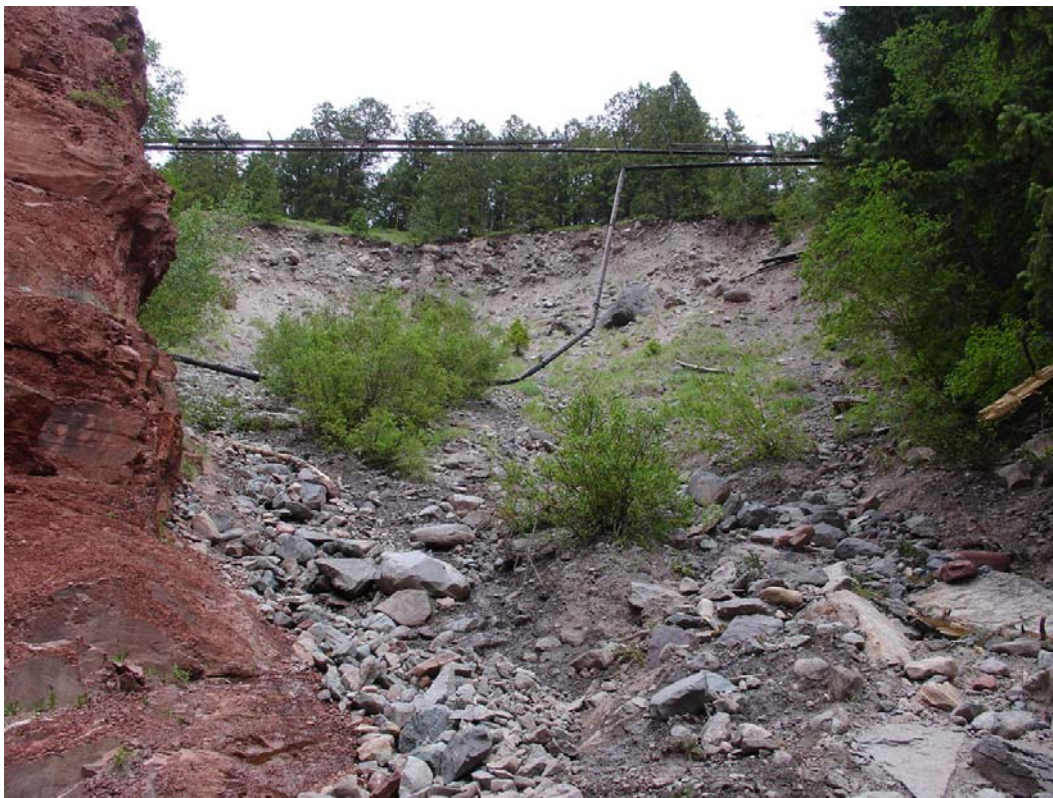
Field observation of the lower reaches of Cornet Creek above the alluvial fan apex indicated the presence of at least three very large mass failure scarps within glacial till deposits on the east side of the creek both up- and downstream of the Falls in the area described as the Liberty Bell Flats on the USGS topographic map (**Plates 2.1 and 2.2**). Saturation-induced mass failure of the till deposits in this location are very likely to have been associated with historic debris flows on the alluvial fan. Cores extracted from trees growing at the base of the middle scarp which is located in the vicinity of the Falls, indicate that the slope failure occurred at least 76 years ago, and thus may have been associated with the 1914 event if it assumed that it took about 17 years for the site to become stable enough for trees to become established. At the very least, mass failure of the tills would have blocked the narrow canyon, and this would have resulted in a dam-break type of flood. The presence of the mass failure scarps in the lower portion of the basin suggests that debris flows are not just generated in the upper basin. Therefore, it is probably not safe to assume that early warning systems located in the upper portion of the basin will always provide advance notice of a debris-flow event prior to its arrival at the apex of the alluvial fan.

Plate 2.1. View upstream of a failure scarp in glacial till deposits located on the east side of Cornet Creek and immediately downstream of the Falls.

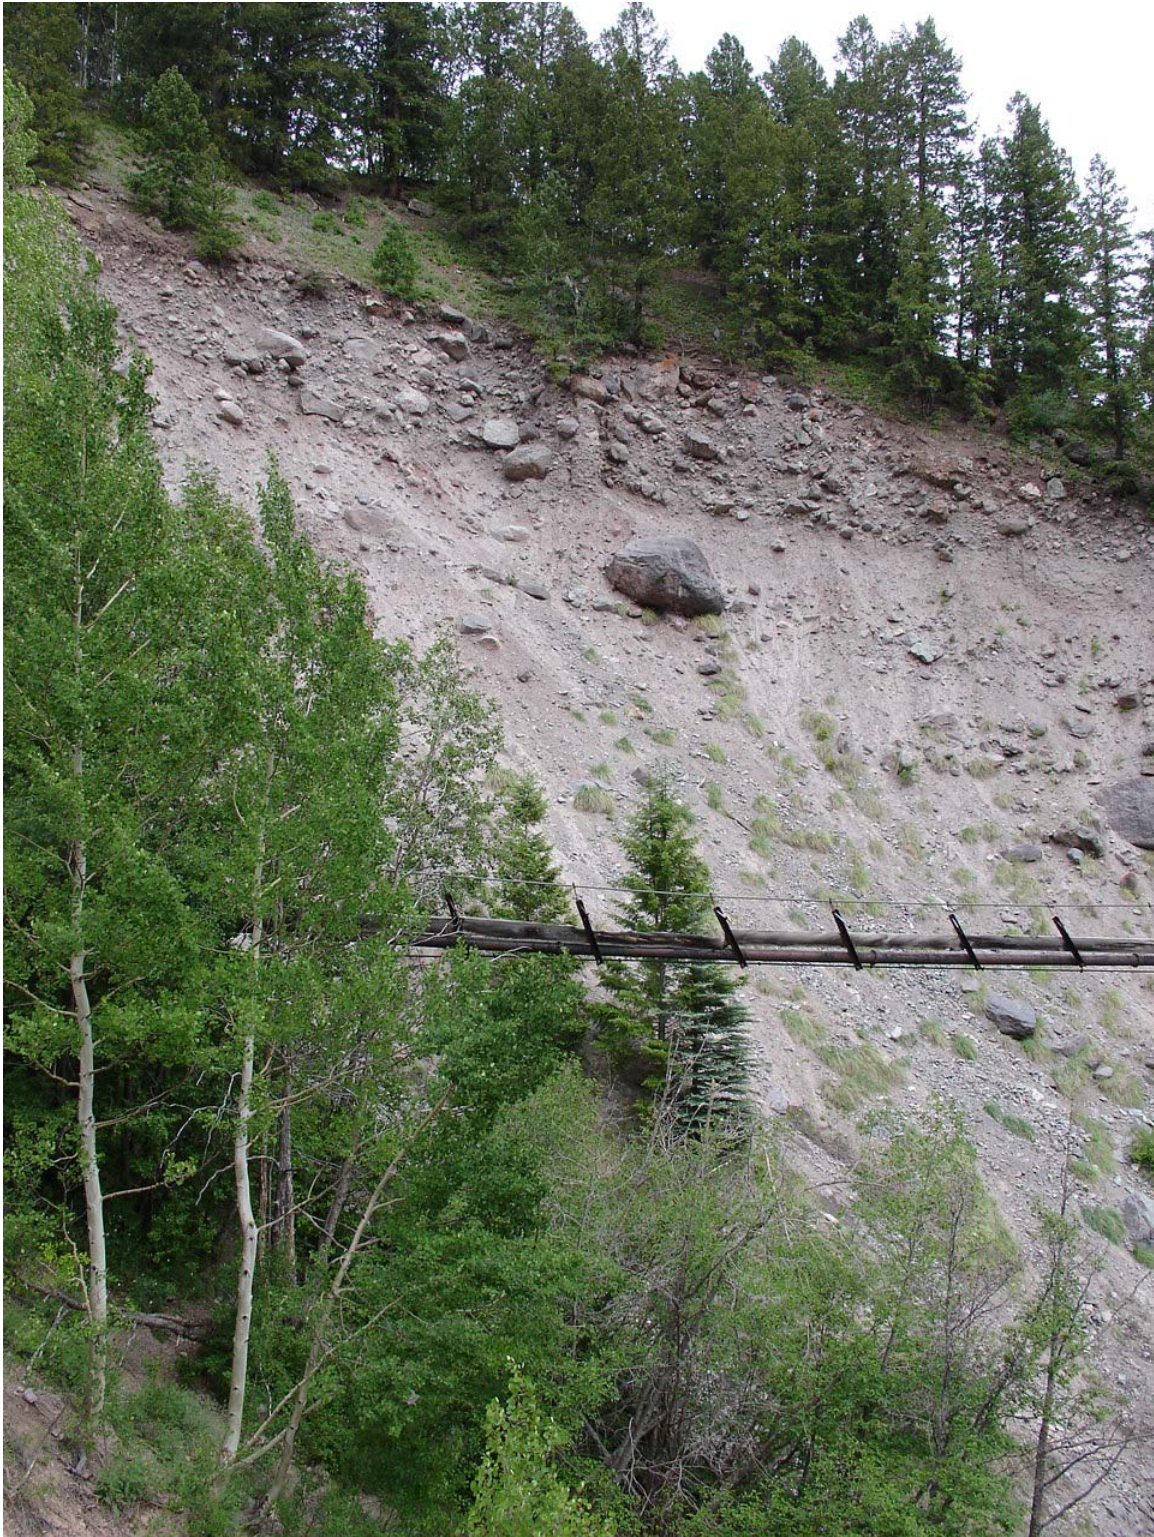
Plate 2.2. View of head of failure scarp on the east side of Cornet Creek upstream of the Falls. The failure took place in glacial till deposits.

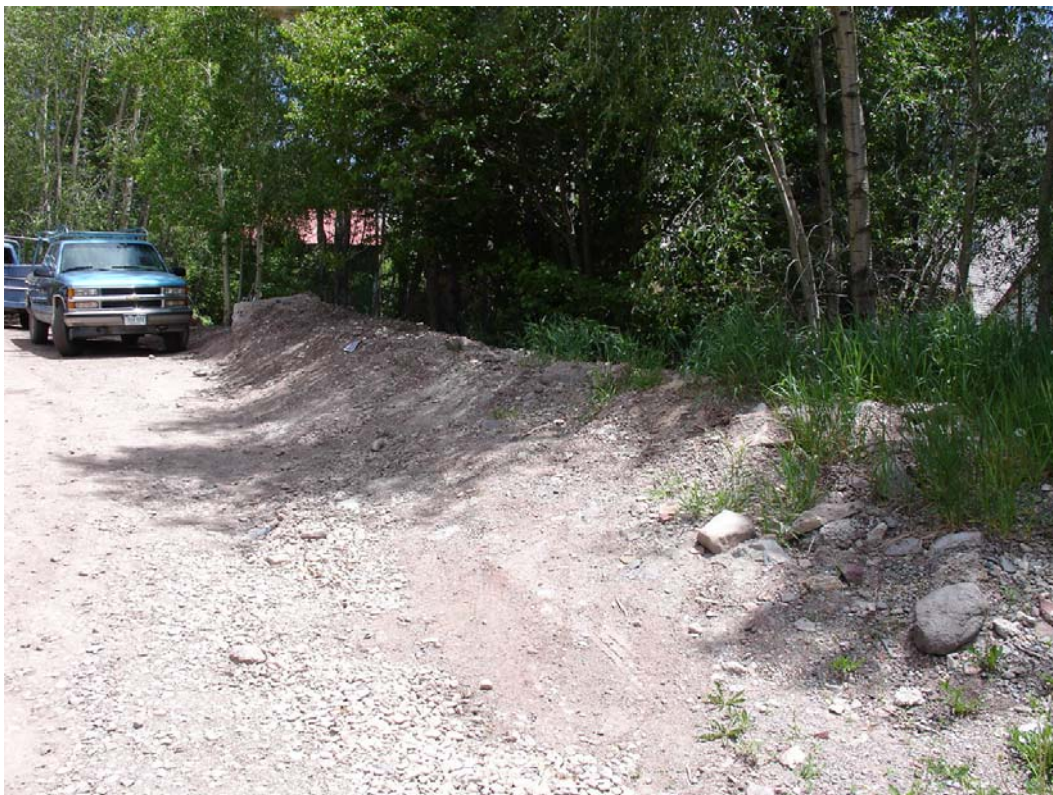
Upstream from Townsend Street, the channel gradient is approximately 10 percent, and larger cobble/boulder steps characterize the bed. This portion of channel also contains larger boulders along the toe of the bank at various locations (Photo 12, Appendix A). However, determination of whether the boulders had been placed naturally or manually could not be ascertained during the field reconnaissance. A small berm has been constructed along the right bank and the adjacent access road (Plate 2.4).

Plate 2.4. View looking upstream at small berm upstream from Townsend Street between access road and right channel bank near Sta 20+00.

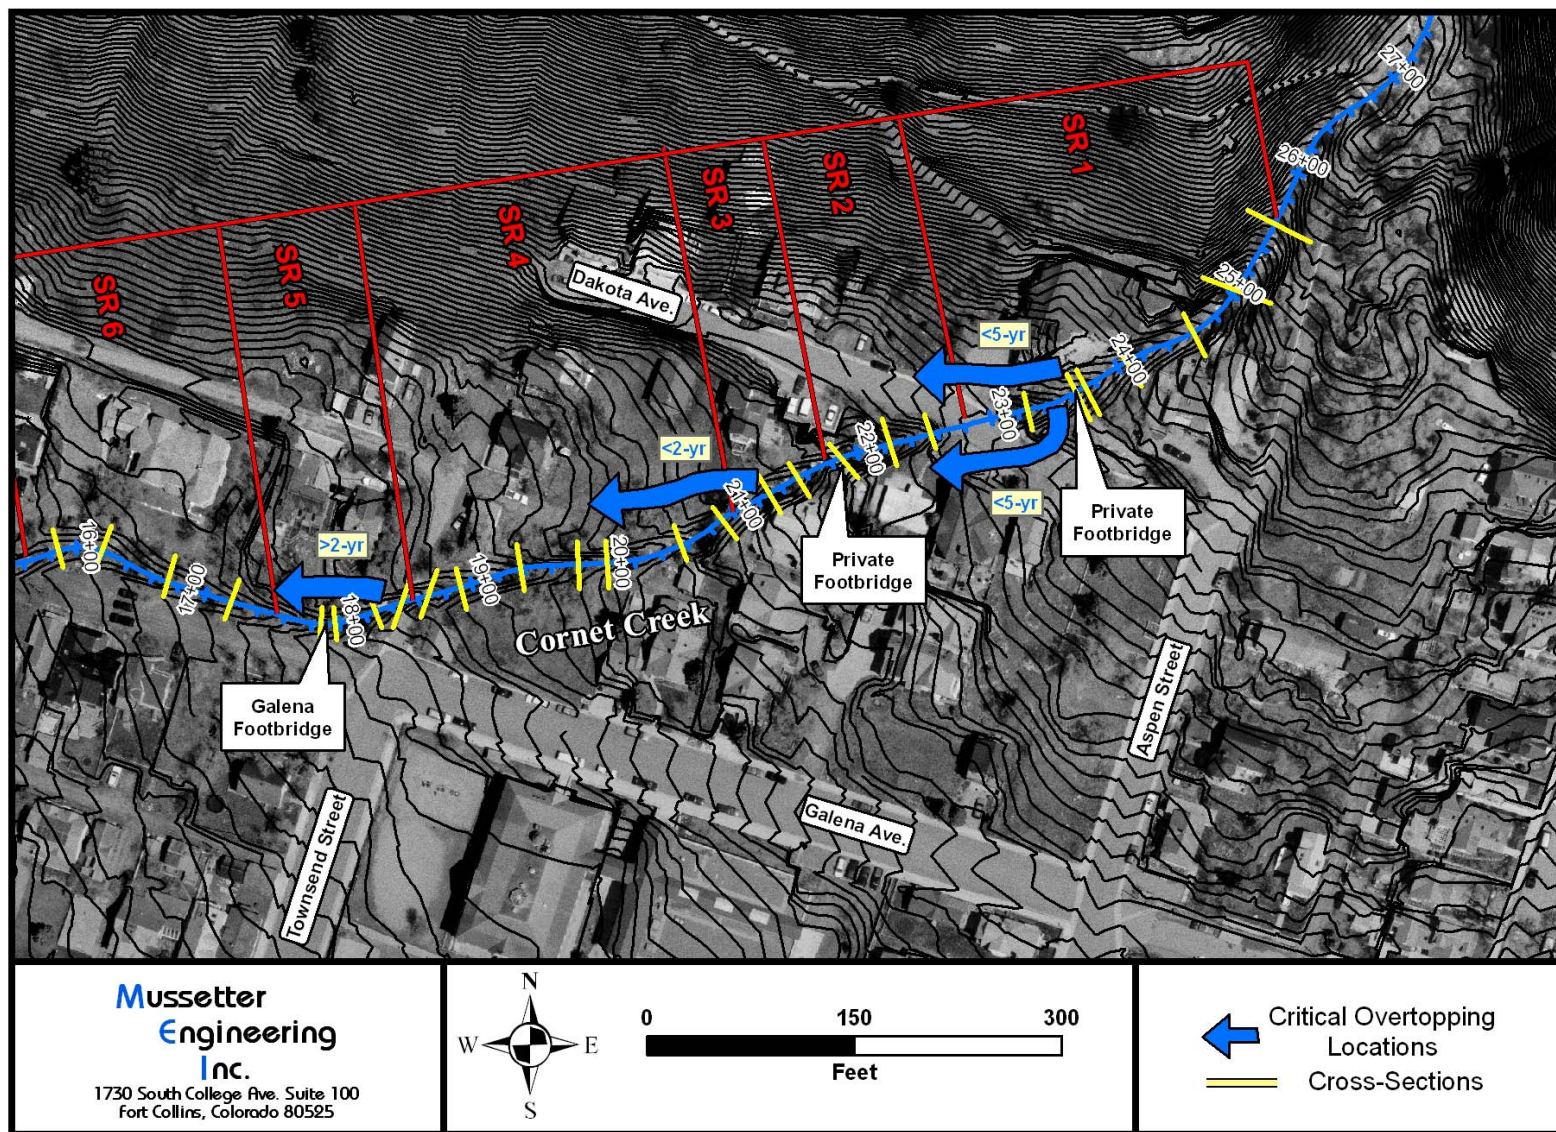
Figure 4.5. Map of Subreaches 1 through 4 of Cornet Creek showing critical channel overtopping locations and the recurrence intervals of the overtopping flows.

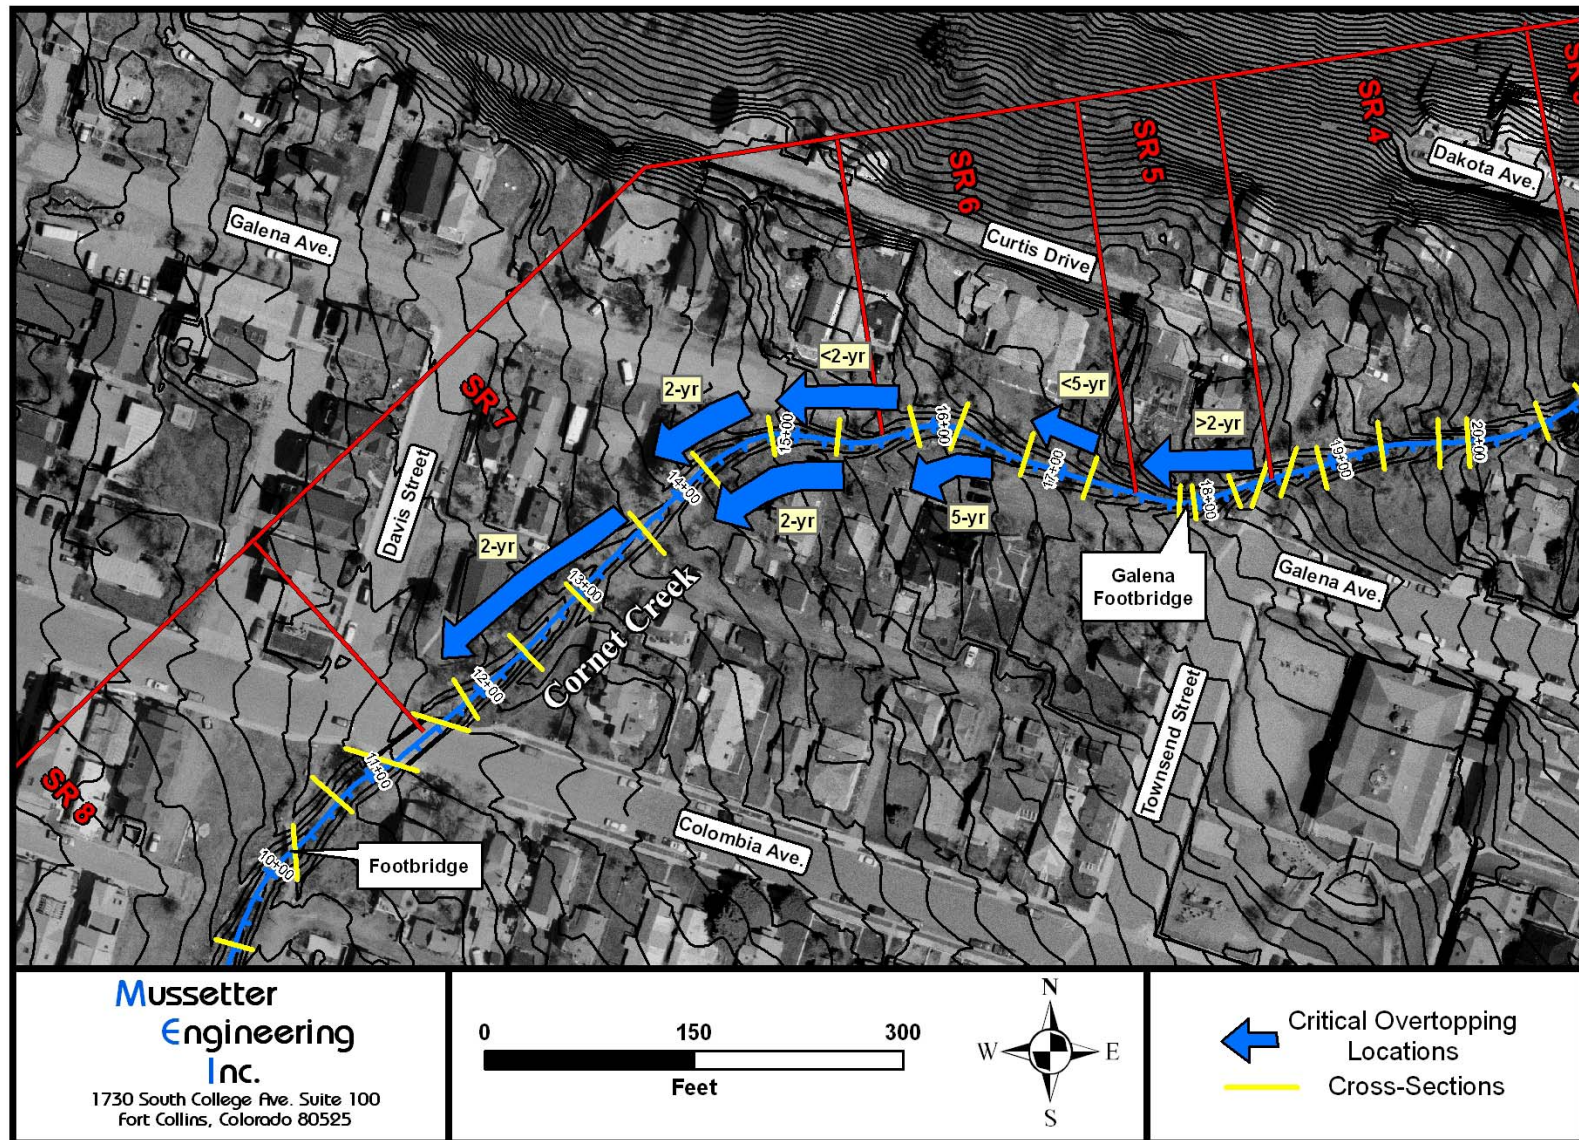
The channel characteristics of Subreach 7 are very similar to those in Subreach 6. Both have similar average channel gradients of about 7 percent (Figure 4.3), and relatively uniform bed and bank profiles. The left bank of the channel tends to be a little higher in the downstream portion of the reach, but the channel capacity is still only about 270 cfs (i.e., slightly less than the 2-year peak; Figure 4.7). Any flow that overtops the right bank in this reach will probably drain in a south-westerly direction away from the channel, but the local topography indicates that flow spilled on the left side is likely to re-enter the channel near the upstream side of Columbia Avenue (Figure 4.8).

Figure 4.8. Map of Subreaches 5 through 7 of Cornet Creek showing critical channel overtopping locations and the recurrence intervals of the overtopping flows.

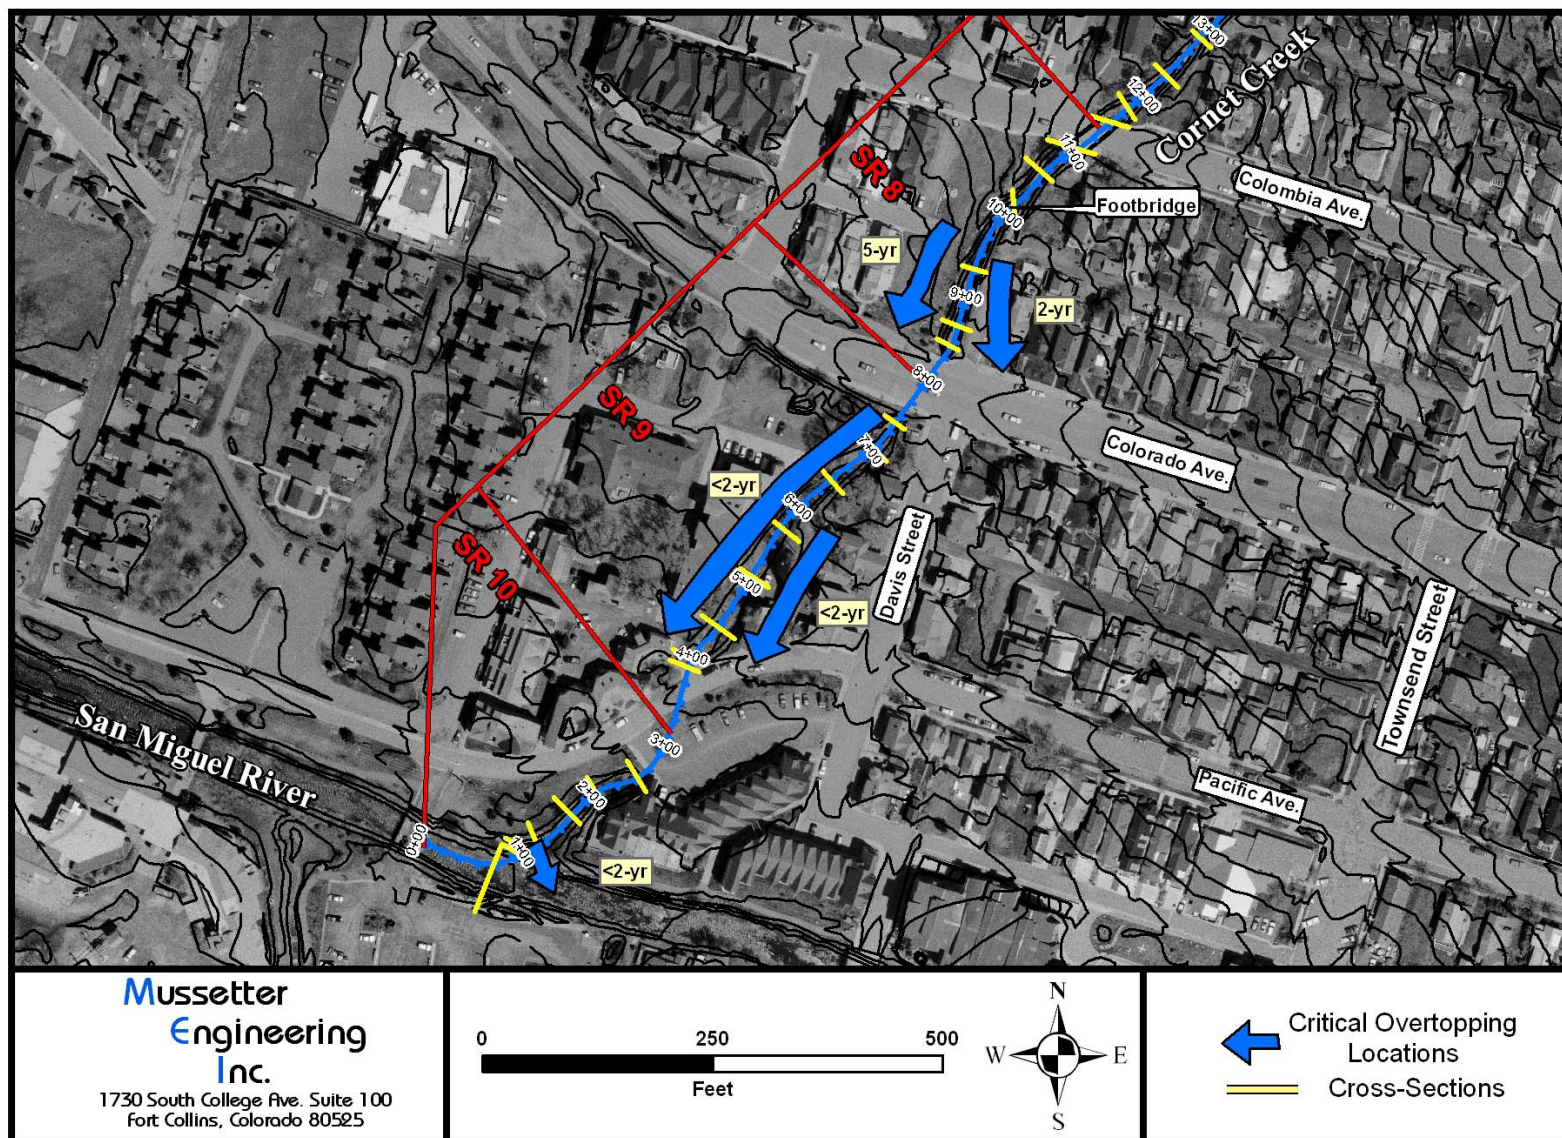
Subreach 9 has a significantly flatter channel gradient (3 percent) than the upstream subreaches (Figure 4.3) and a much reduced channel capacity. The relatively low bank heights in this reach result in a channel capacity of only about 100 cfs (Figure 4.10). Except along the left bank immediately downstream from Colorado Avenue, flows can spill out of the channel throughout the entire subreach, impacting numerous adjacent properties. Left overbank flow will likely re-enter the channel on the downstream side of Pacific Avenue, but most of the flows within the right overbank will continue in a southwest direction away from the channel (Figure 4.11).

Figure 4.11. Map of Subreaches 8 through 10 of Cornet Creek showing critical channel overflowing locations and the recurrence intervals of the overflowing flows.

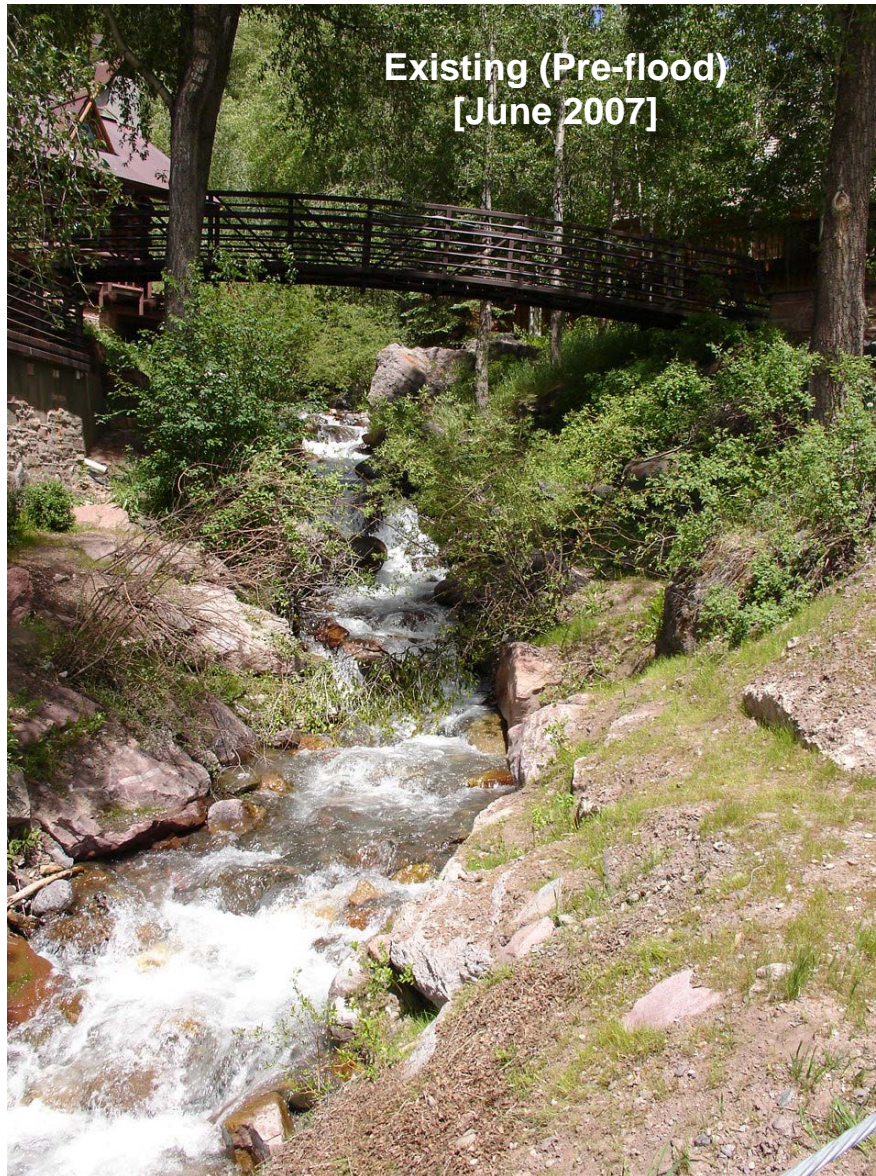
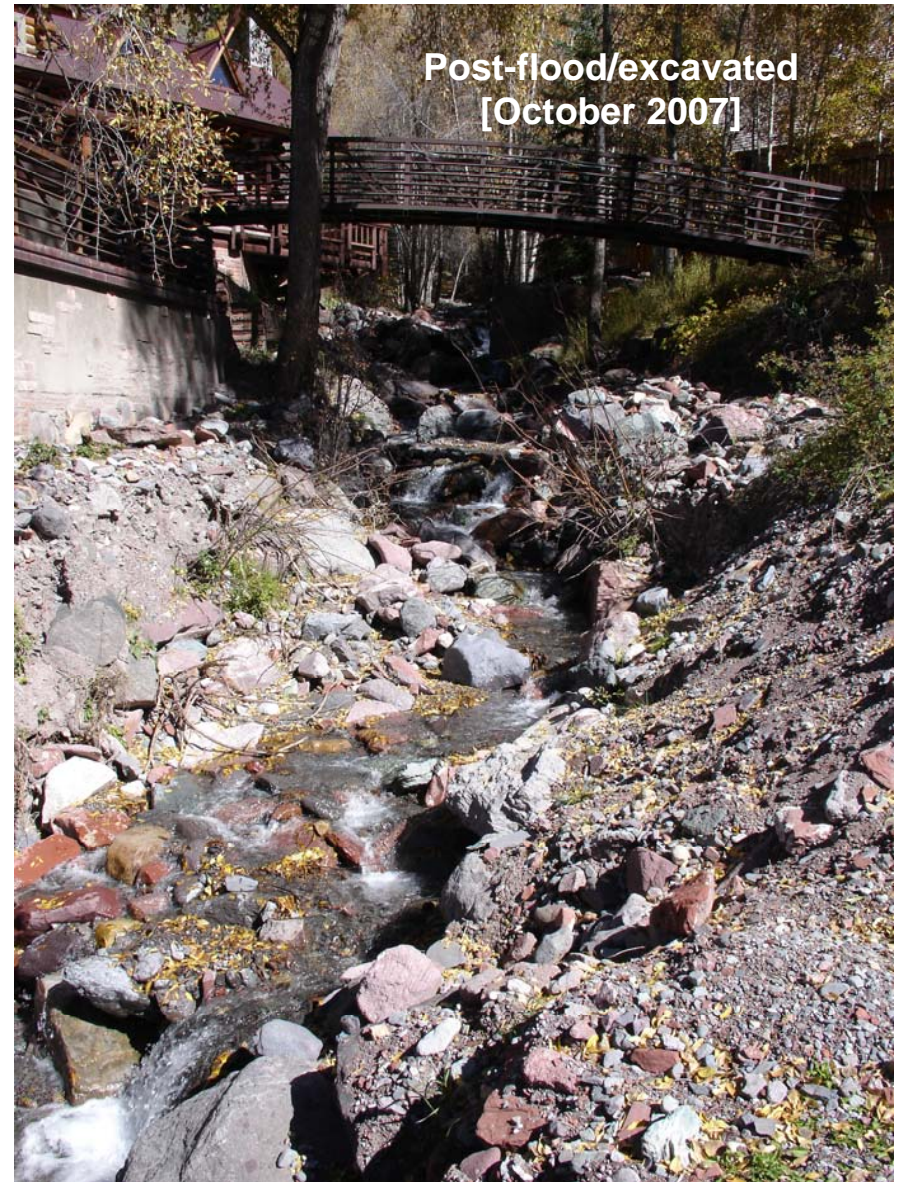
Plate 4.1. View looking upstream at Cornet Creek from Dakota Avenue, showing existing (pre-flood) and post-flood/excavated conditions.

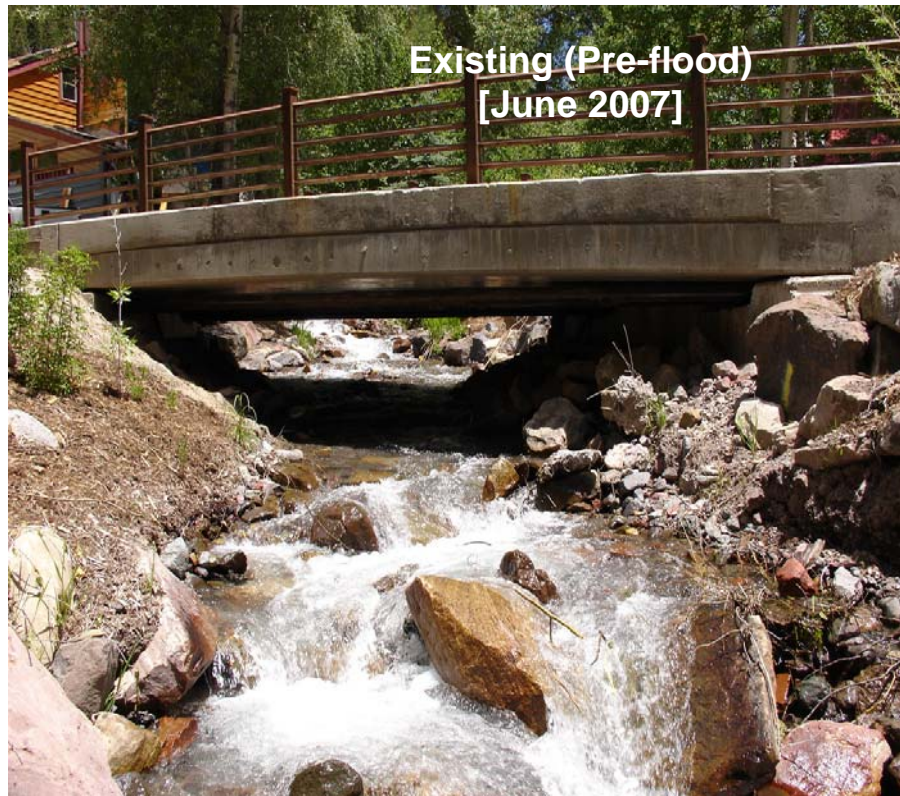
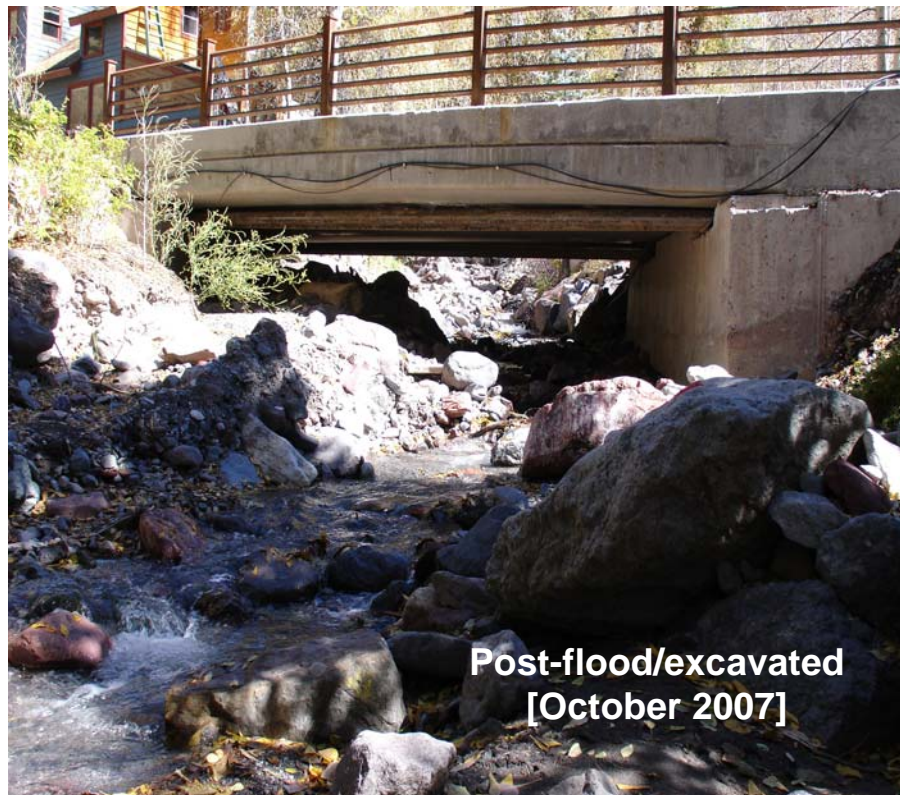
Plate 4.2. View looking upstream at Townsend Street Bridge on Cornet Creek, showing existing (pre-flood) and post-flood/excavated conditions.

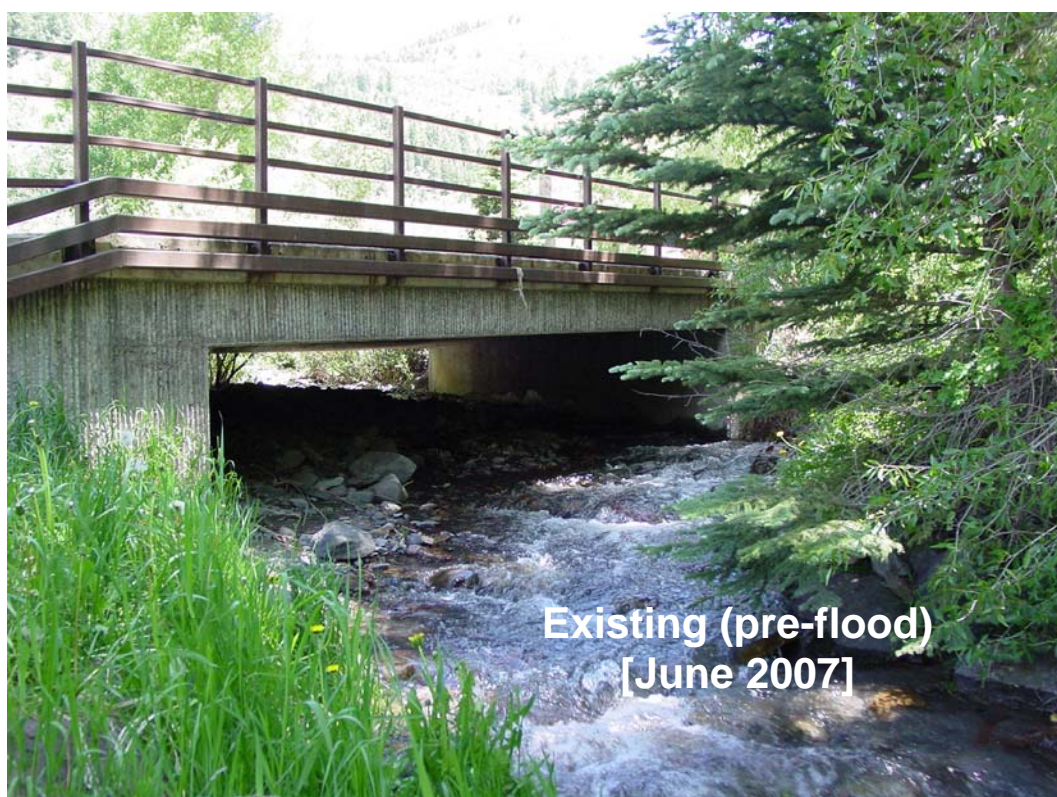
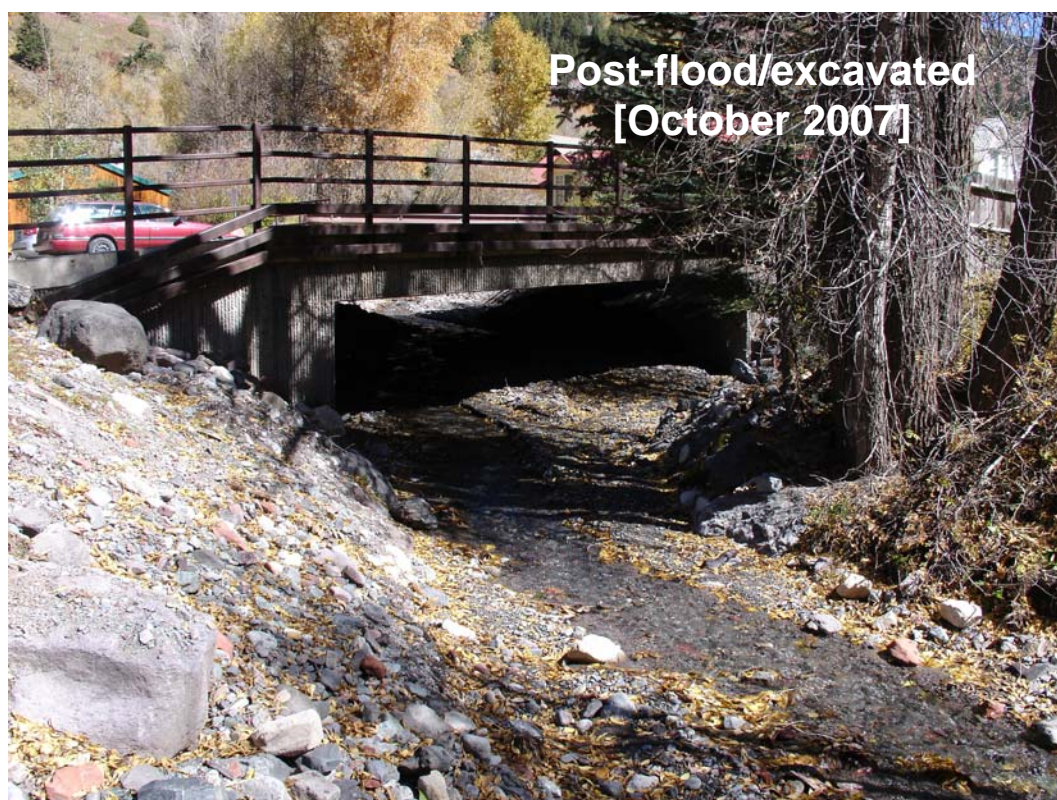
Plate 4.3. View looking upstream at Columbia Avenue Bridge on Cornet Creek, showing existing (pre-flood) and post-flood/excavated conditions.

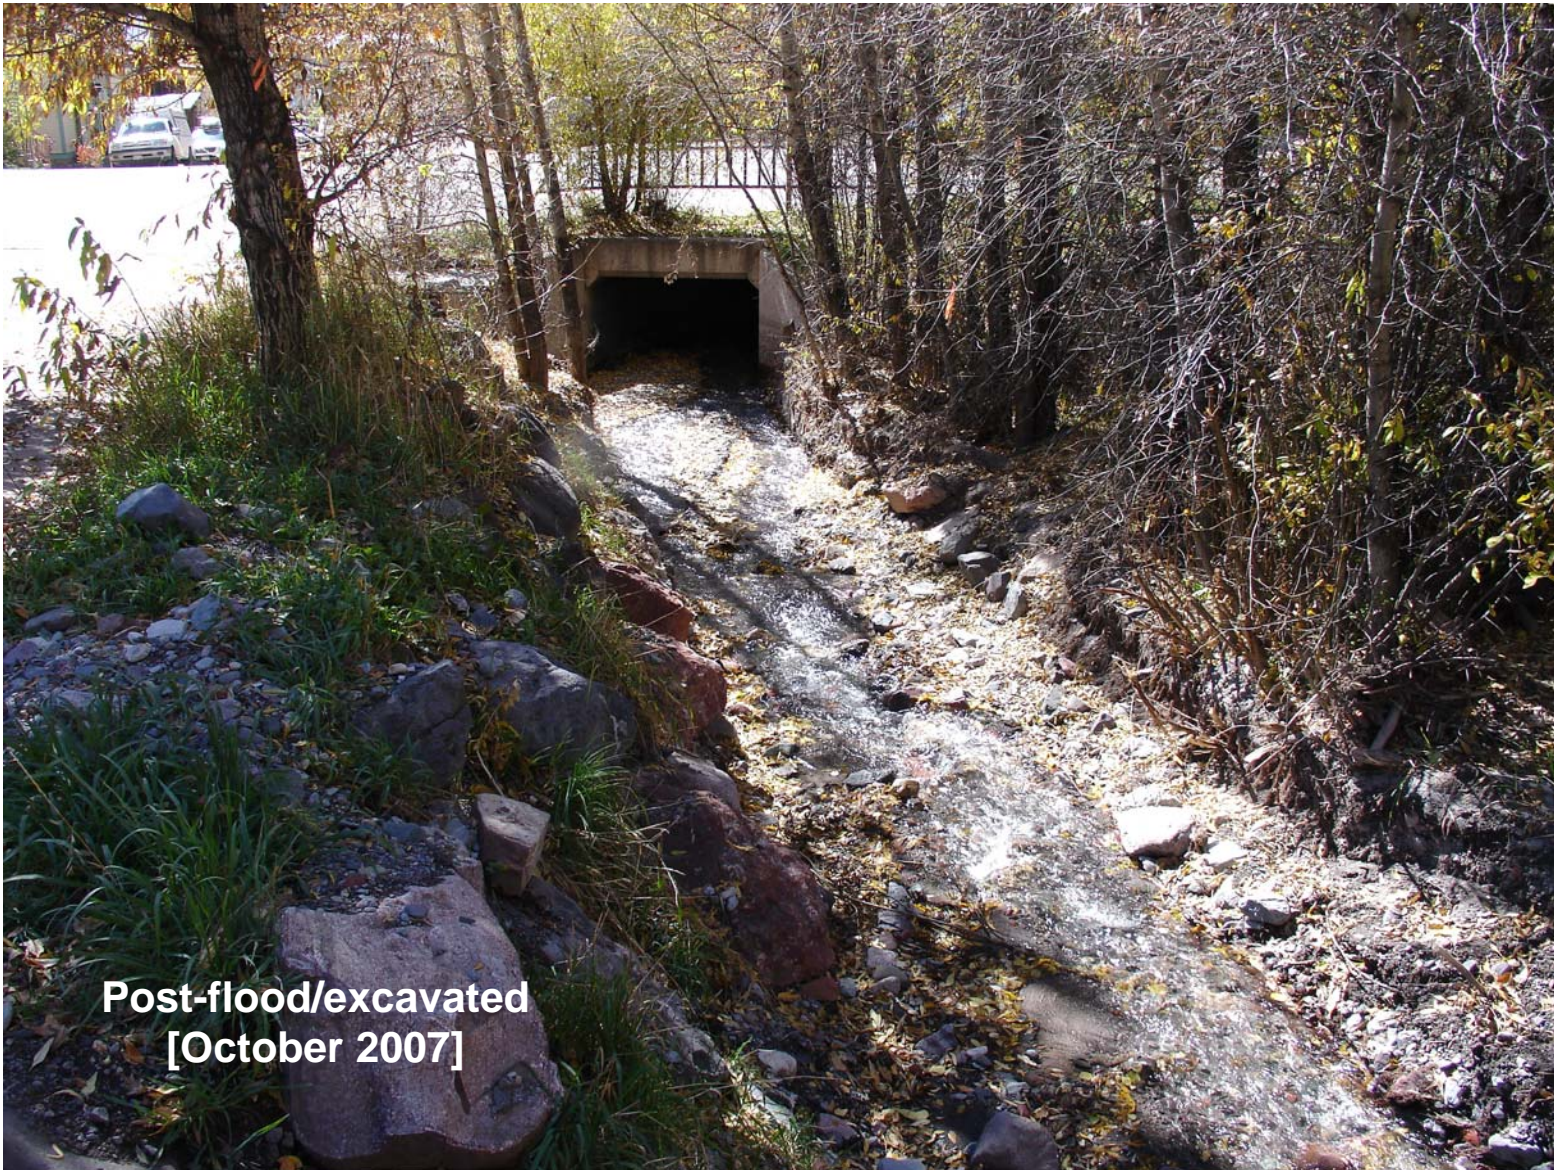
Plate 4.4. View looking downstream along Cornet Creek at Colorado Avenue showing post-flood/excavated conditions in the channel.

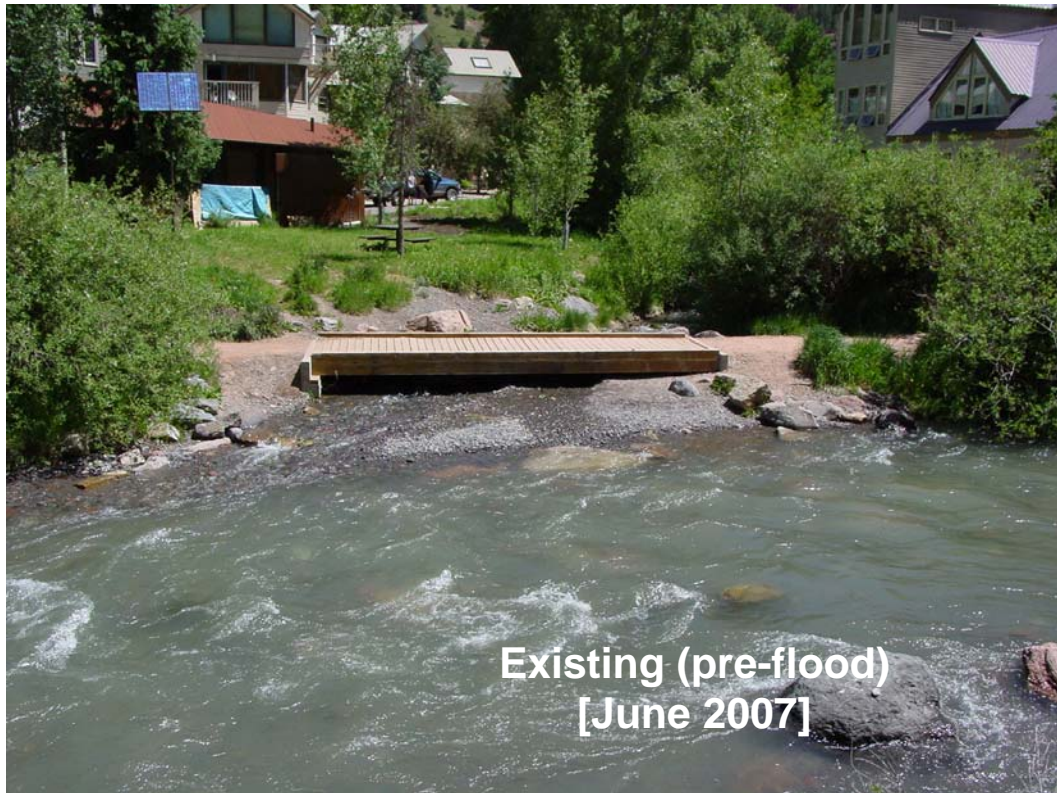
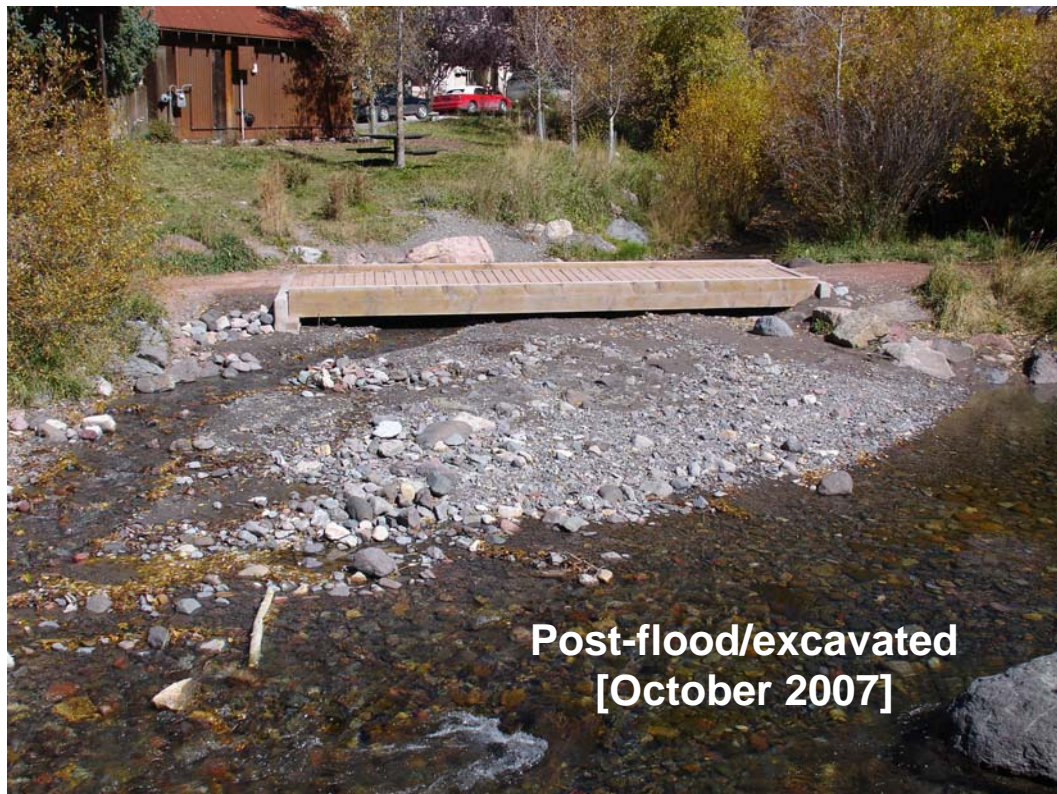
Plate 4.5. View looking upstream at the San Miguel River Trail Footbridge on Cornet Creek, showing existing (pre-flood) and post-flood/excavated conditions.
